Blockley co-op shop

TREE REPORT

Surveyor: John Crawshaw, M.Arbor.A. RFS Cert Arb
Crawshaw Environmental

Survey Date: November 2010

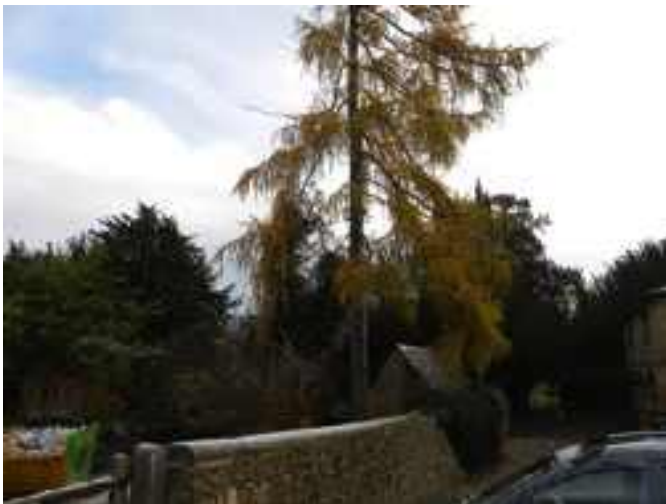
T1 Larch

T1 Common Larch *Larix decidua* **Cat R**

T1 is an unusual specimen which has suffered significant damage in terms of losing most of its branches on the southern side. Local knowledge indicates an adjacent Black Poplar fell down onto the Dovecote and as a result had the effect of knocking off the branches, leaving an uneven canopy and resulting in quite an ugly specimen.

Evidence shows that the root system is uplifting the surfaced area and maybe starting to impact on the adjacent wall also.

The landscape character and amenity value of this tree has been compromised and evidence shows structural damage to surrounding structures caused by tree roots. Consideration should be given to the removal of this tree and a relevant replacement planted to replace.

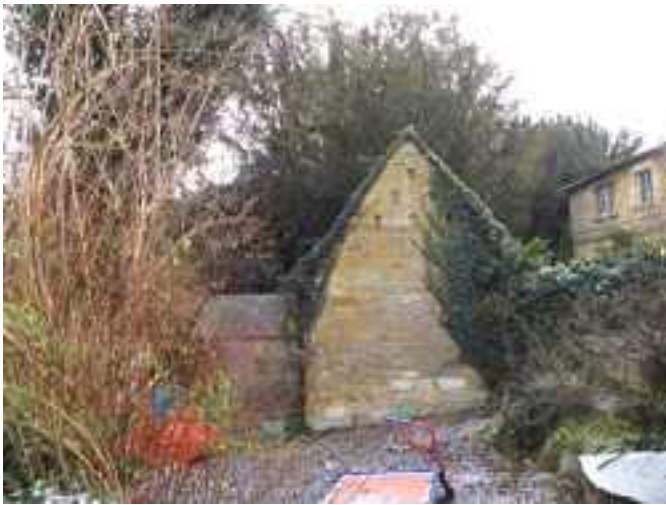
T2 & T3 Toilet block

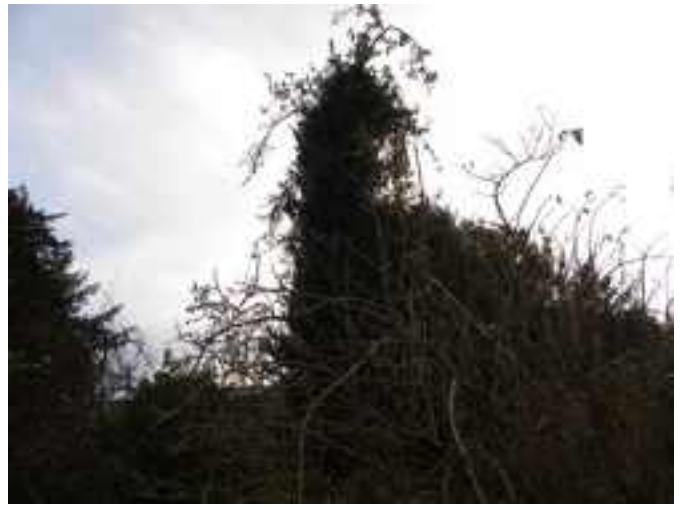
T2 Apple *Malus* **Cat C2**

T2 is heavily ivy clad which could be an indication the tree is in decline and could be hiding structural defects not easily seen from the ground e.g. rot. However areas of rot on the main trunk can be seen and although not causing a health and safety risk at this time will become worse and will have to be monitored.

This tree is of fair quality and is in decline, it should be monitored for increasing structural defects or could be considered for removal if it were to pose a risk to the adjacent structures.

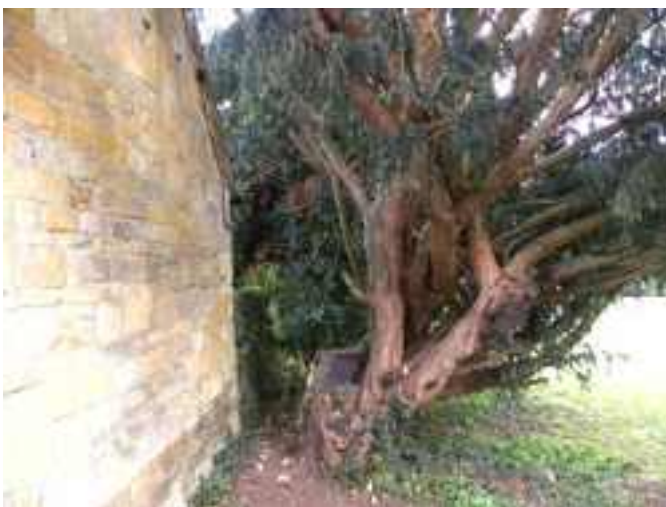
T3 Yew *Taxus baccata* **Cat A1,2,3**

T3 has suffered major pruning in the past probably to elevate damage to the toilet block. Small amounts of rot are present between the multi stems. Further pruning may be needed to protect adjacent structures. Stem rot fungus has been identified on other Yews within the Church yard, but does not seem to be an issue to this tree at this time.

This tree has suffered severe pruning in the past and as a result has left it with a compromised shape and could have opened up the opportunity for disease to enter. However, it appears at this time to be in good health and should be monitored. Consideration should be given to future sympathetic pruning to accommodate nearby structures.

T3 Yew severe pruning

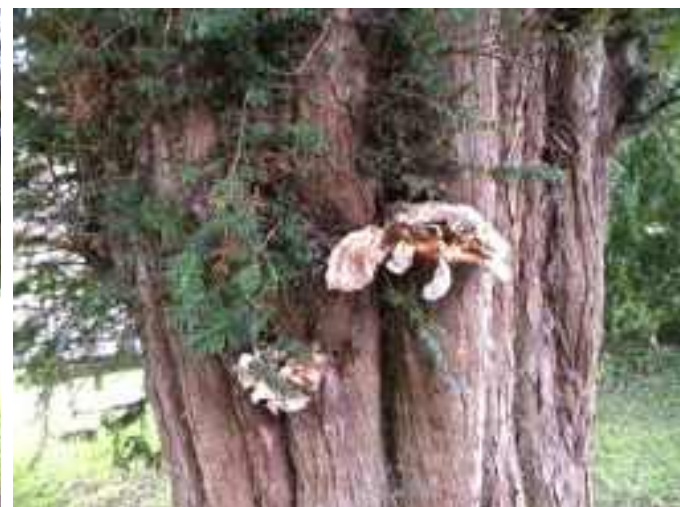
Decay fungus on nearby tree (not within this report) but worthy of mention
