**Blockley Cooperative
Blockley
Gloucestershire**

Archaeological Evaluation

CA Project: 3417
CA Report: 11137

June 2011

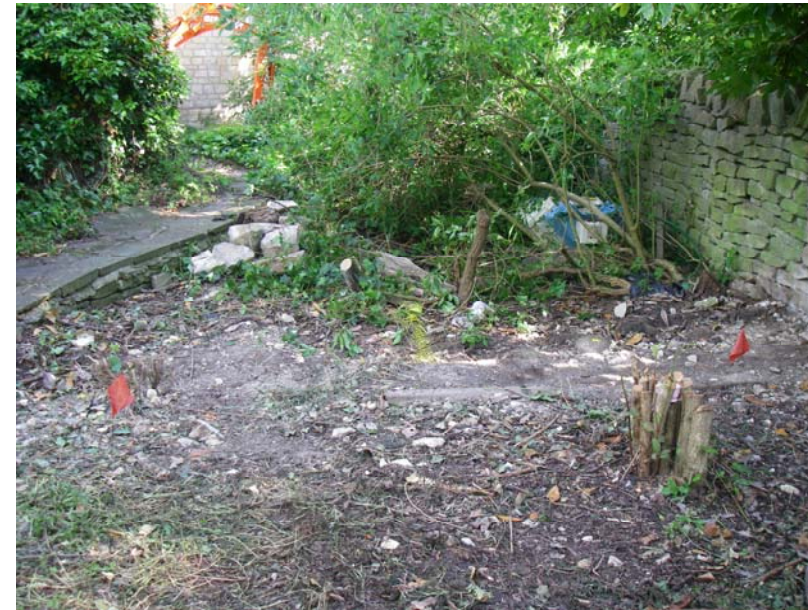
Photograph of trench location, marked by flags, and showing the wall, pond and path, looking north

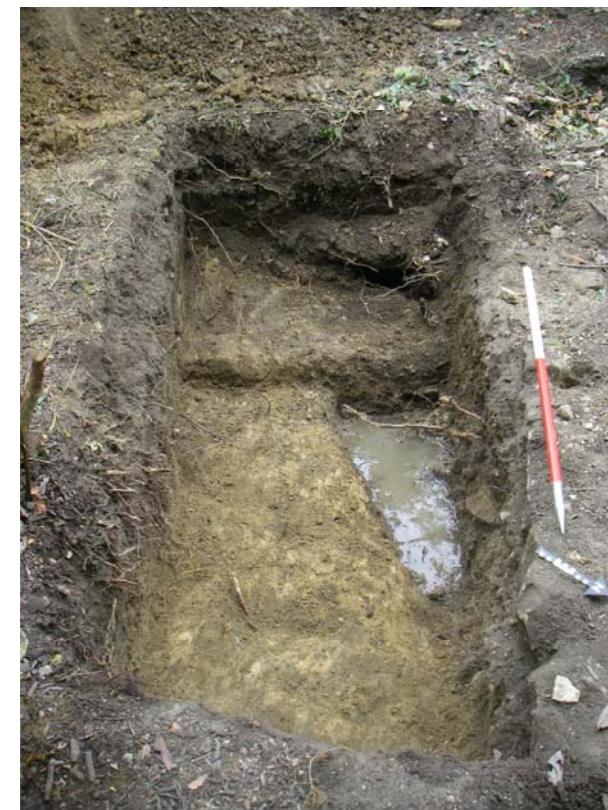
Photograph of Trench 1, looking South-west (scale 1m)

- 3.4 A later phase of water management activity is represented by the still-active watercourse running underneath drystone wall 103, which was used as a culvert for a small modern pipe.
