Blockley co-op shop

TREE REPORT

Surveyor: John Crawshaw, M.Arbor.A. RFS Cert Arb
Crawshaw Environmental

Survey Date: November 2010

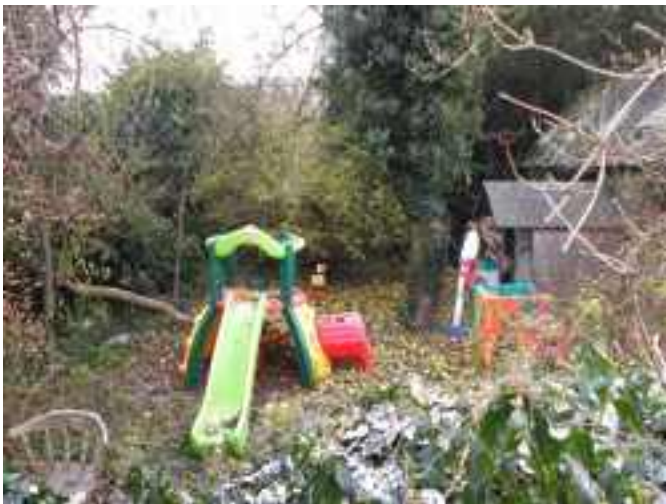
T2 Apple

T2 is heavily ivy clad which could be an indication the tree is in decline and could be hiding structural defects not easily seen from the ground e.g. rot. However areas of rot on the main trunk can be seen and although not causing a health and safety risk at this time will become worse and will have to be monitored.

This tree is of fair quality and is in decline, it should be monitored for increasing structural defects or could be considered for removal if it were to pose a risk to the adjacent structures.

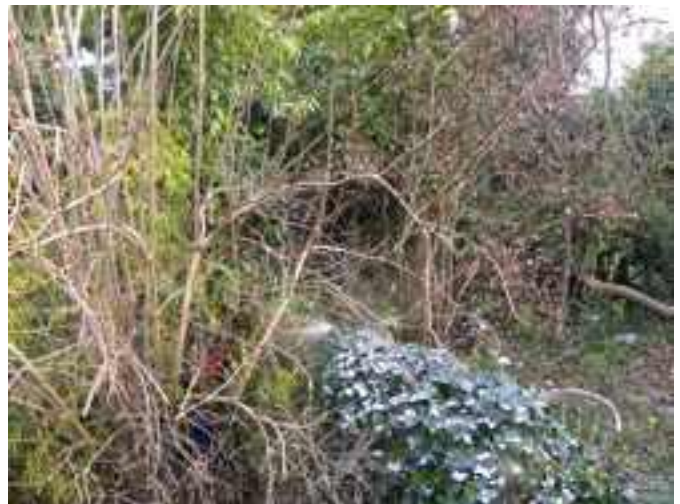
Various small shrubs
